Manhole Inspection Summary

Manhole # S61O__007MH

Location Address: **Interstate Ave.**

Cross Street: **Boston St.**

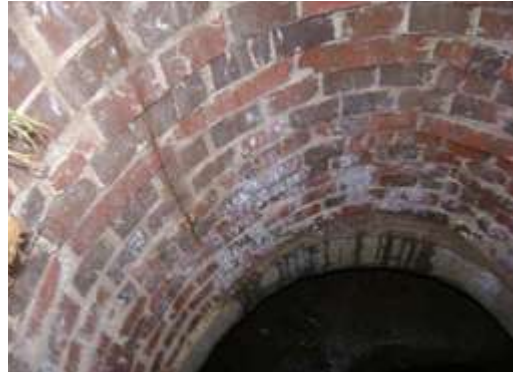
Defect 3

infiltration evidence at base of chimney.

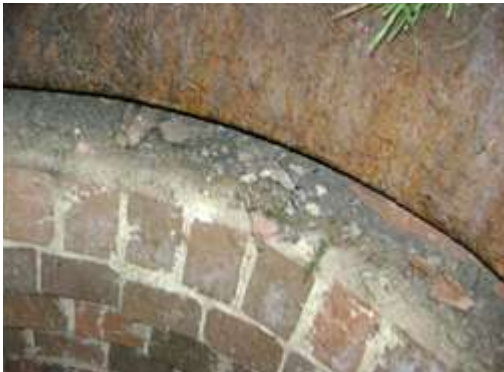
Defect 2

Condition: ☐ Sound ☐ Cracked ☐ Root Intrusion ☒ **Loose Brick** ☒ **Deteriorated**

missing mortar at frame adjustment

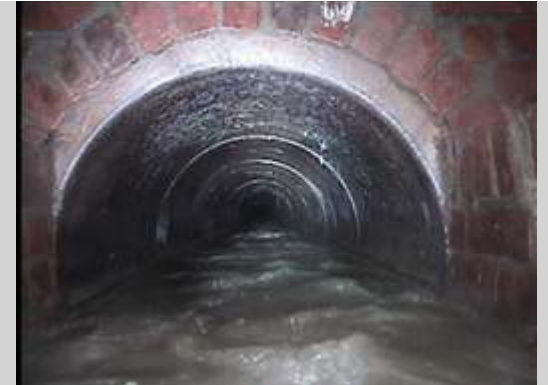
12 O'Clock Outflow

Pipe Height: **24** (in.) Rod and Bar (Angled)
Pipe Material: **Clay** ☐ Pipe Lined
Invert Depth: **15.58** (ft.) Flow Characteristics: **Fast**
Deposits: ☒ None ☐ Mud ☐ Sludge ☐ Debris ☐ Grease
Silt Depth: (in.) Deposits Extent:
Infiltration: **None** Pipe Seal Cond: **Sound**

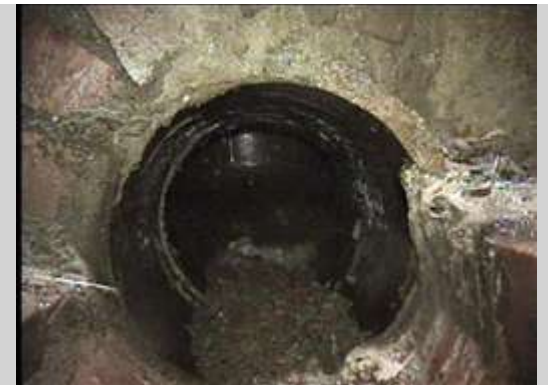
3 O'Clock Inflow

Pipe Height: **8.4** (in.) Rod and Bar (Angled)
Pipe Material: **Clay** ☐ Pipe Lined
Invert Depth: **14.25** (ft.) Flow Characteristics: **None**
Deposits: ☒ None ☐ Mud ☐ Sludge ☐ Debris ☐ Grease
Silt Depth: (in.) Deposits Extent:
Infiltration: **None** Pipe Seal Cond: **Sound**

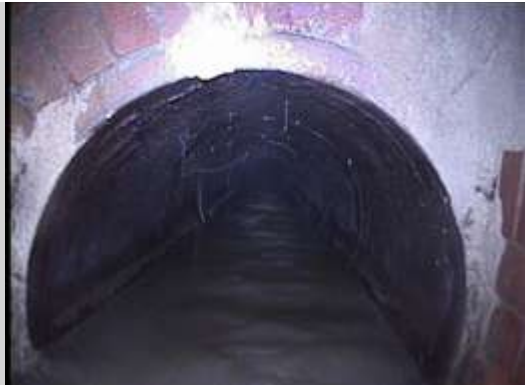
6 O'Clock Inflow

Pipe Height: **21.6** (in.) Rod and Bar (Angled)

Infiltration: **None** Pipe Seal Cond: **Sound**

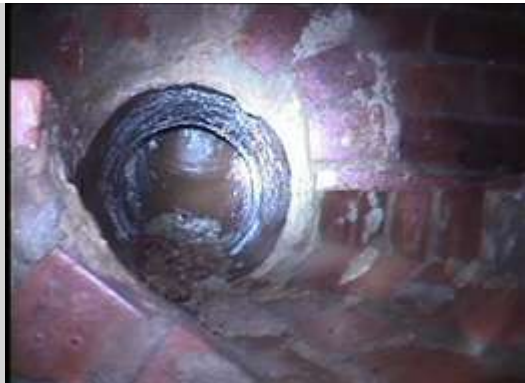
9 O'Clock Inflow

Pipe Height: **8.4** (in.) Rod and Bar (Angled)

Infiltration: **None** Pipe Seal Cond: **Sound**
